# BIOMONITORING

## EXXARO COMMITMENT STATEMENT

# MATLA GRASS OWL PROTECTION PLAN

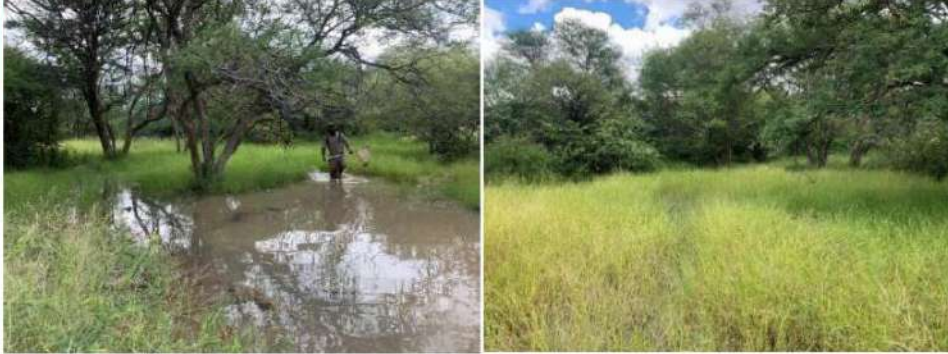
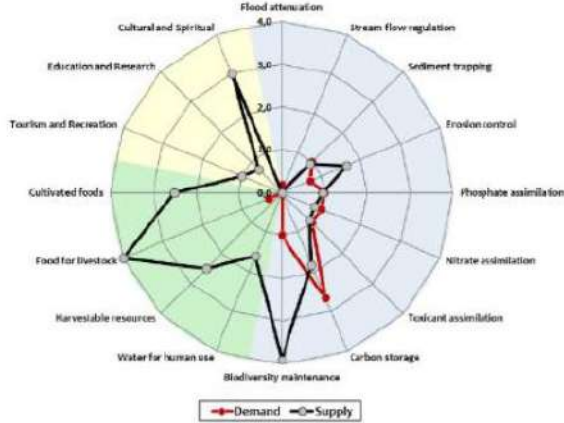
Table 4-10: Summarised findings for Pan 15

Monitoring Characteristics	Description	Site Images and EcoServices Diagram	
PES	<p style="text-align: center; background-color: green; color: white; font-weight: bold; padding: 5px;">B</p> <p>Pan 15 was also inundated with water. This pan is wooded with various <i>Vachellia</i> and <i>Senegalia</i> species and thus provides excellent habitat for birds. Good basal cover was observed with many grass and sedge species observed. Few impacts were observed aside from evidence of grazing, however these levels appear to be fairly normal.</p>

EcoServices	<p>The main services provided by Pan 15, and all pans in general in the Limpopo region, are biodiversity maintenance, water provision and grazing. Pans provide point sources of water and food in an otherwise dry habitat thereby increasing species composition and richness. The importance scores for Regulating and Supporting Services were very low to high, Provisioning Services were very low to moderately high and Cultural Services were very low to moderately low.</p>

EIS	High	Changes (2018-2021)	No significant changes. →

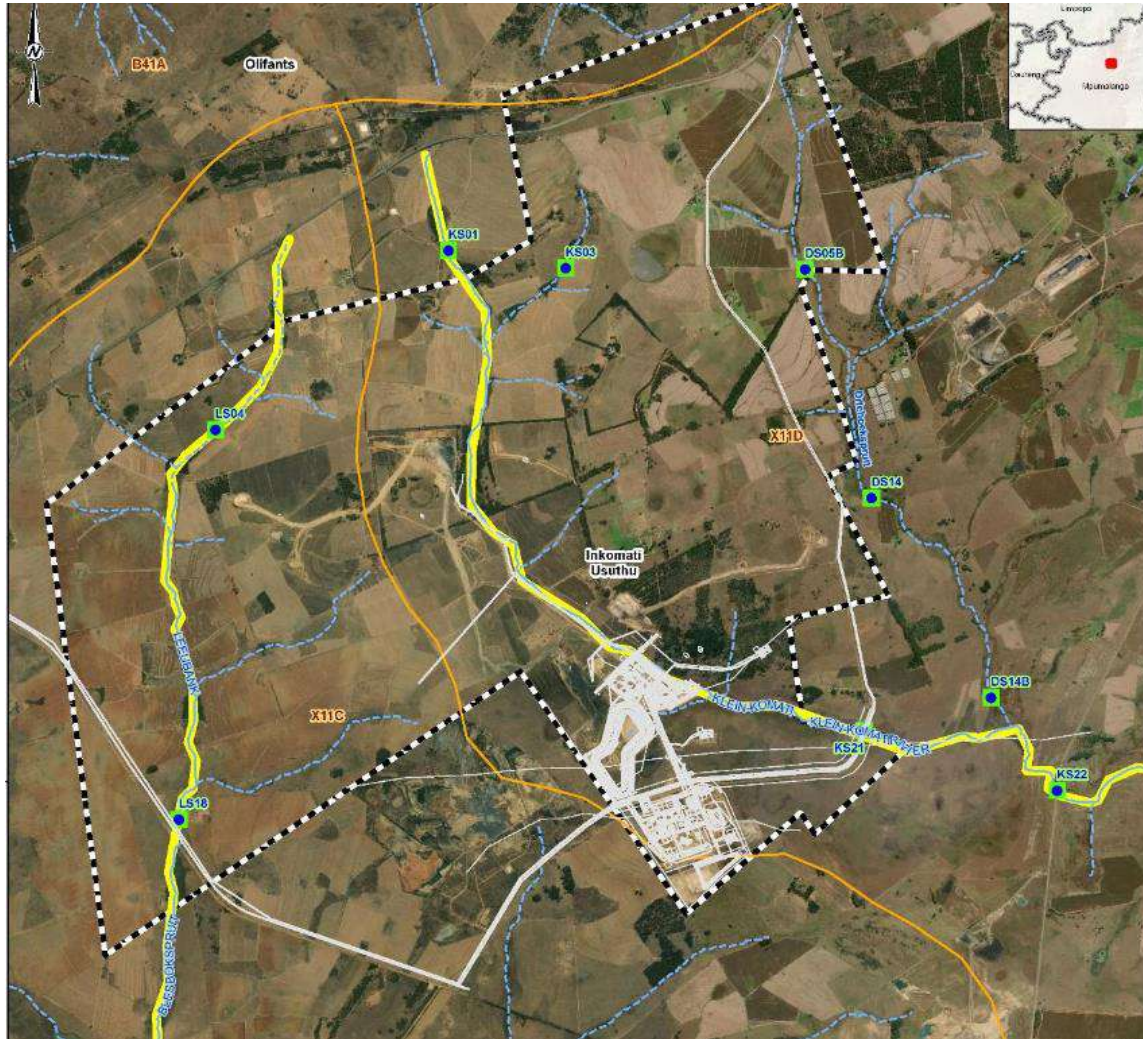
# AQUATIC BIOMONITORING

- Water quality measurements recorded during the Dry season survey ranged from those within acceptable values
- and those that fell outside the acceptable range generally within the TWQR for all parameters, particularly for
- TDS which recorded an acceptable value for all sites.
- pH and DO , recorded values that were outside the prescribed TWQR at some of the monitored sites. These values were generally consistent with historical values that have shown to fluctuate both spatially and temporally since the commencement of the monitoring survey.
- The fluctuation of water quality measurement has been seen at both upstream and downstream systems as well as sites within the Leeubankspruit which is located outside the mining operations

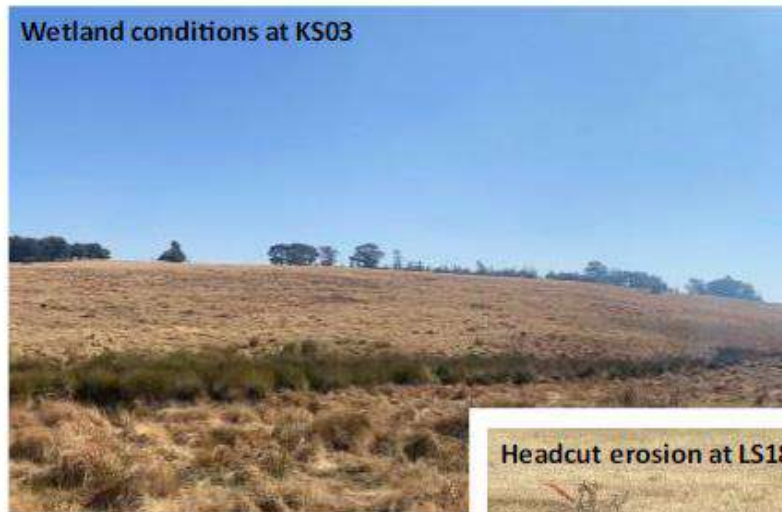
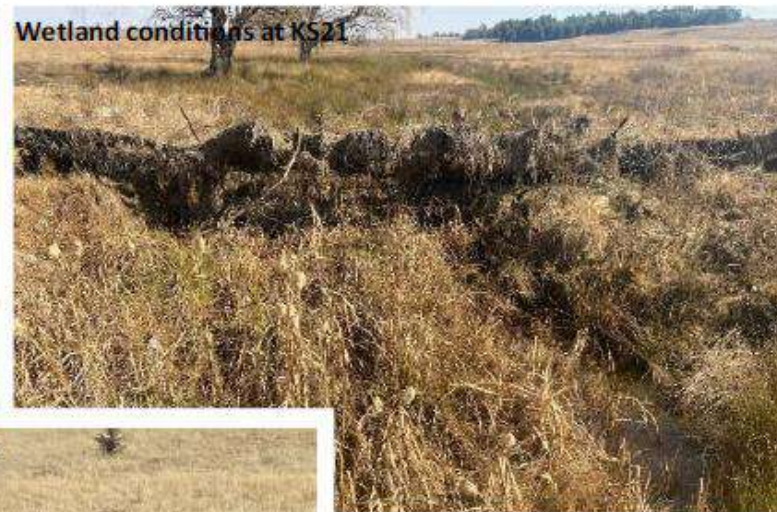
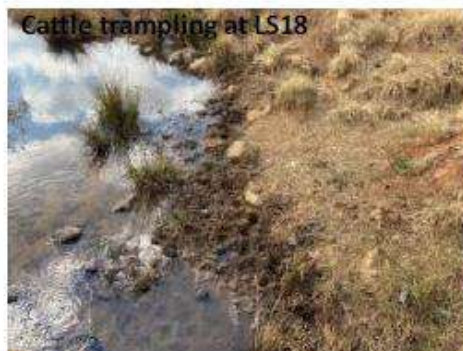
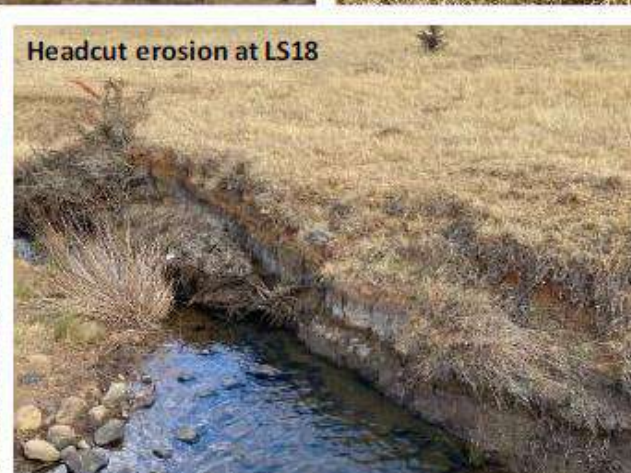
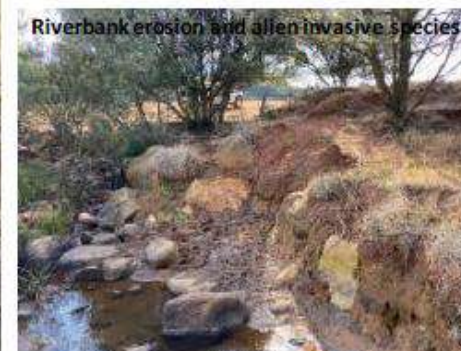
# INTERGRATED HABITAT ASSESSMENT SCORING

- The IHAS results obtained during the dry monitoring showed KS22 to have good habitat availability
- Areas of concern are KS03, KS21 and LS18.

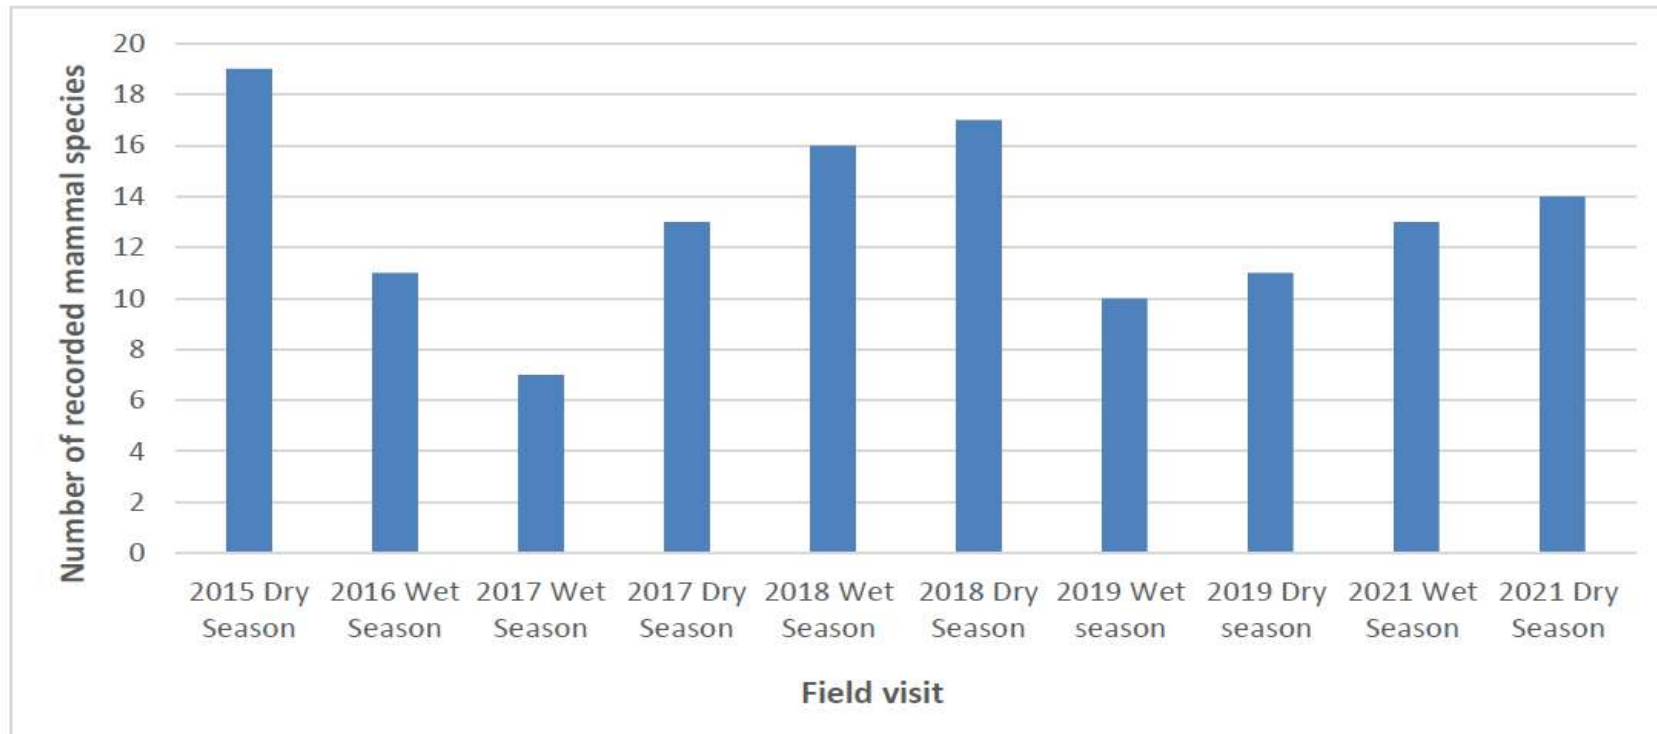
# NUMBER OF MAMMAL SPECIES RECORDED 2015-2021

- The total number of mammals of conservation importance confirmed in the study area is nine.

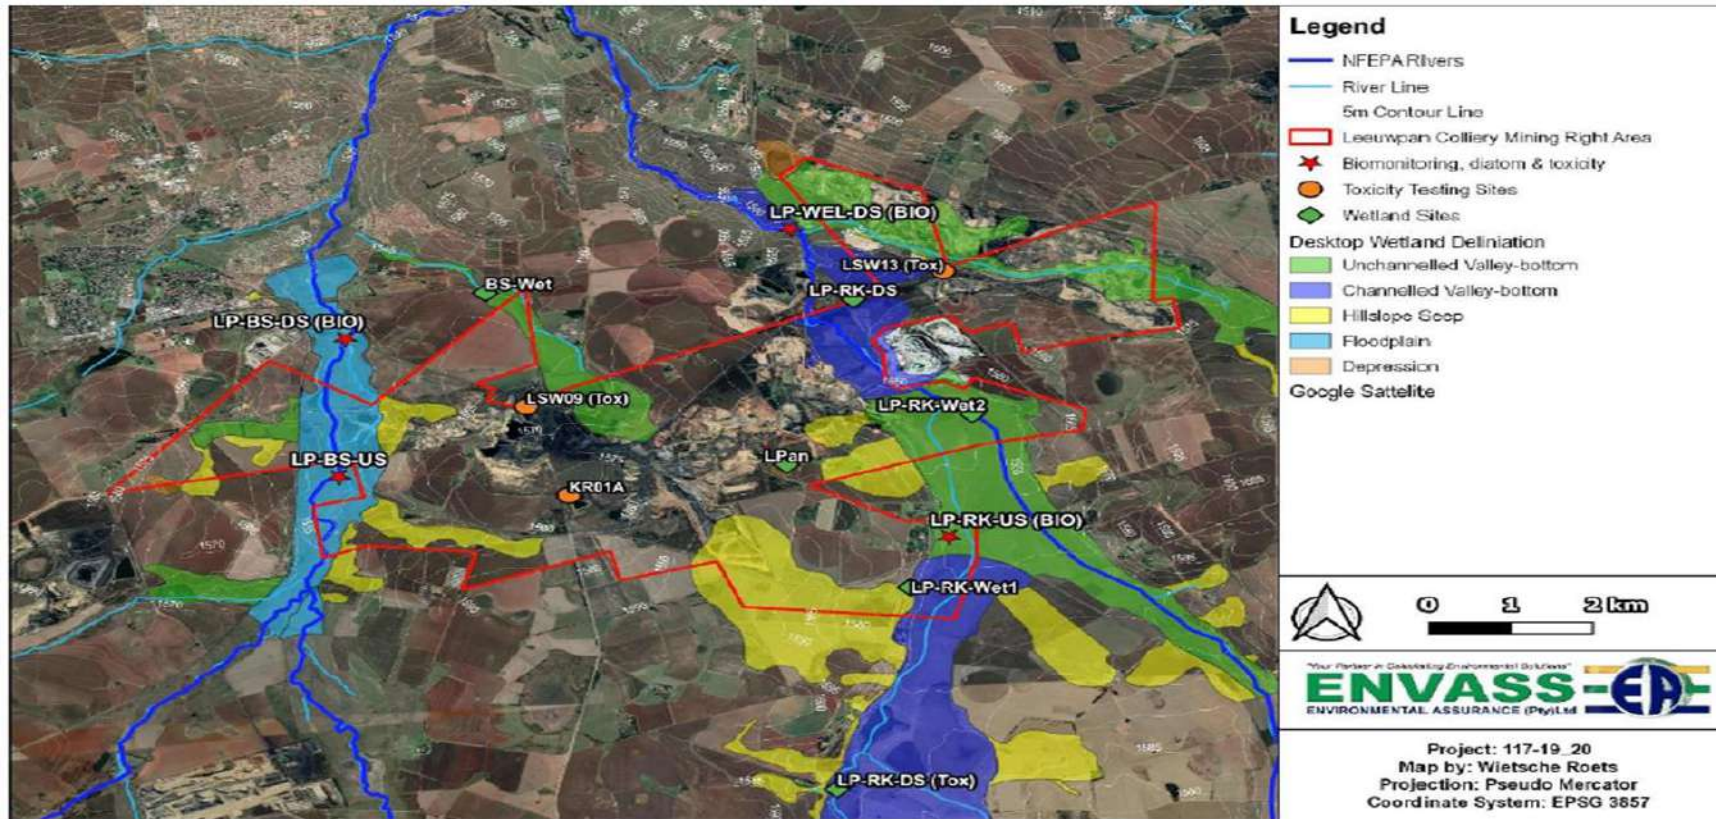
# BIOMONITORING POINTS

- The primary objective of this aquatic biomonitoring assessment is to gather results from the potentially at-risk aquatic systems in the vicinity of the Leeuwan Colliery to ascertain whether the production and associated activities have had an impact on the Present Ecological State (PES) of the systems

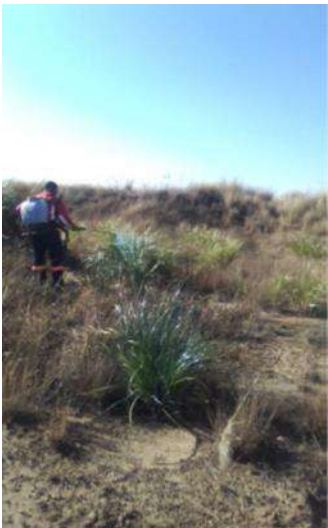
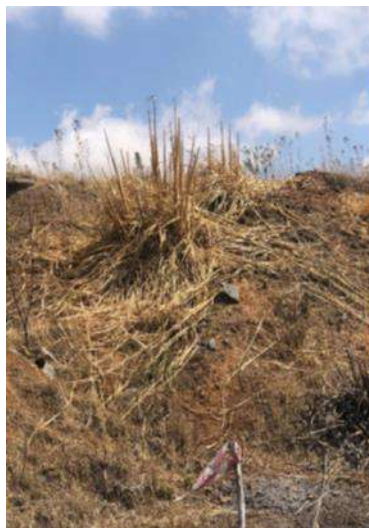
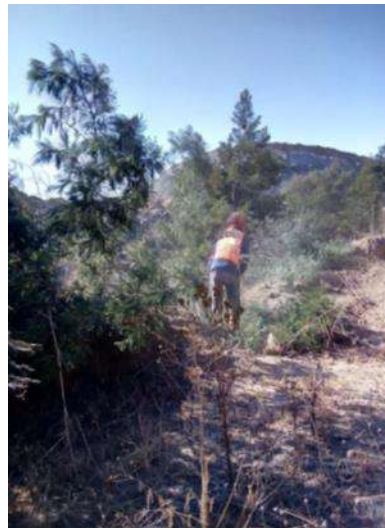
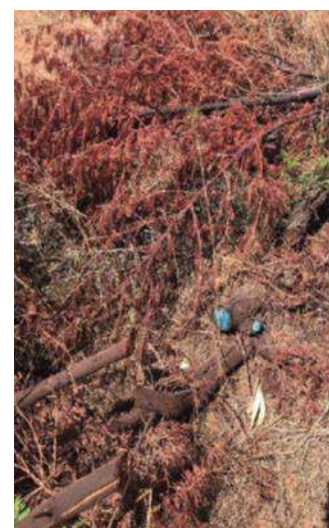
# BIOMONITORING AND ALIEN INVADER MANAGEMENT

Years	Hectares covered
2019	172.69
2020	146.05
2021	118.20

- Pampas grass
- Black wattle
